EVALUATION OF NATURAL LIGHTING SYSTEM OF LECTURE BUILDING

ABSTRACT

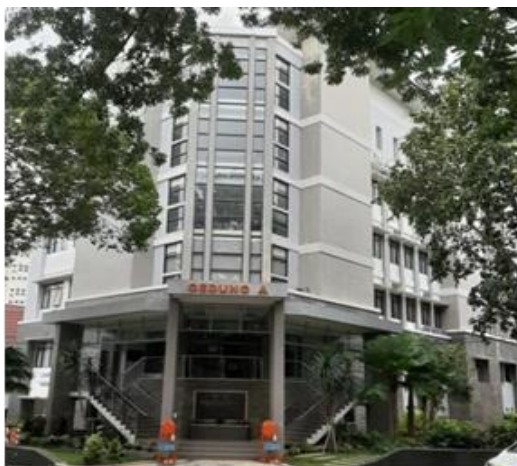
Picture 2. The Front View of The Building

Building entrance is west-oriented yet the west facades has the smallest area of all the facades. In floor 3 to 6, the west facades were almost entirely in the form of window. The front view of the building can be seen through **Figure 2** as follows.

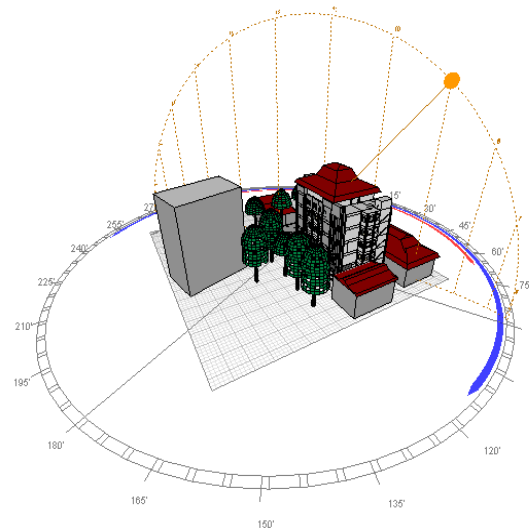
Picture 3. Sun Trajectory

Field measurement was conducted in 24 March 2021 at 08.00, 12.00 and 16.00 WIB with overcast sky condition and no rain. Based on the result of the simulation, the position of the sun in March is perpendicular to the top of the building. The trajectory of the sun can be seen in **Figure 3** below.

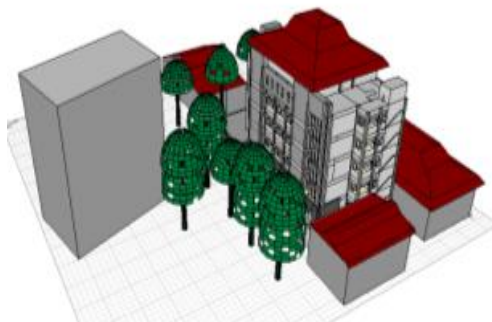
Picture 4. Building Modeling

The model used to analyze the Ecotect is adjusted to the condition of the existing building. Several obstruction such as vegetation in its surrounding is also adjusted although the model has not been perfect yet and several obstruction details were ignored. The building modeling can be seen through **Picture 4** below.
